Manhole Inspection Summary

Manhole # S45II_035MH

Insp Date: **4/29/08 3:54 PM**

Location Address: **Gay**

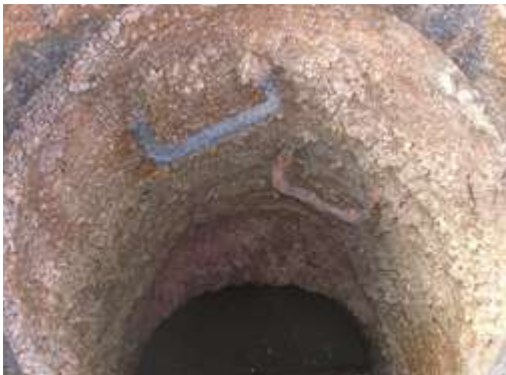
Defect 1

☒ **Leaks**

Frame Leaks

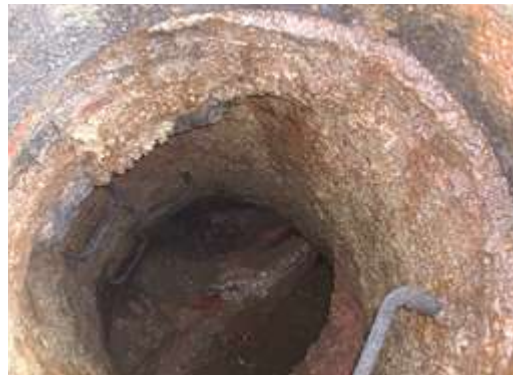
Defect 2

Infiltration: ☐ None ☐ Joint ☐ Cracks ☒ **Mortar** ☐ Roots ☐ Wall

Infiltration: ☐ None ☐ Joint ☐ Cracks ☐ Mortar ☐ Roots ☒ **Wall**

Infiltration

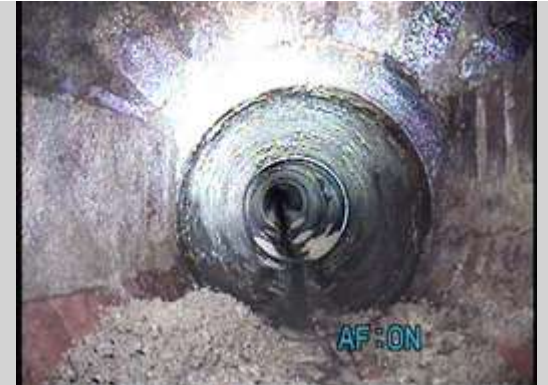
12 O'Clock Outflow

8 in. Circular Gravity Sewer
Pipe Out @ 12 O'Clock

Pipe Height: **8.4** (in.) Rod and Bar (Angled)
Pipe Material: **Clay** ☐ Pipe Lined
Invert Depth: **9.90** (ft.) Flow Characteristics: **None**
Deposits: ☒ None ☐ Mud ☐ Sludge ☐ Debris ☐ Grease
Silt Depth: (in.) Deposits Extent:
Infiltration: **None** Pipe Seal Cond: **Sound**

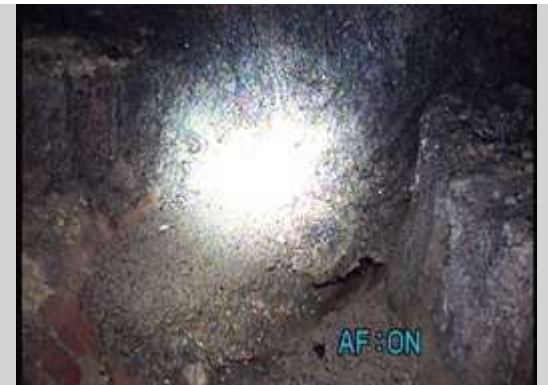
3 O'Clock Inflow

6 in. Circular Gravity Sewer
Pipe In @ 3 O'Clock

capped at 3 o'clock pipe

Pipe Height: **3.6** (in.) Rod and Bar (Angled)
Pipe Material: **Clay** ☐ Pipe Lined
Invert Depth: **1.00** (ft.) Flow Characteristics: **None**
Deposits: ☒ None ☐ Mud ☐ Sludge ☐ Debris ☐ Grease
Silt Depth: (in.) Deposits Extent:
Infiltration: **None** Pipe Seal Cond: **Sound**

Connects To: **Stub connection / abandoned**

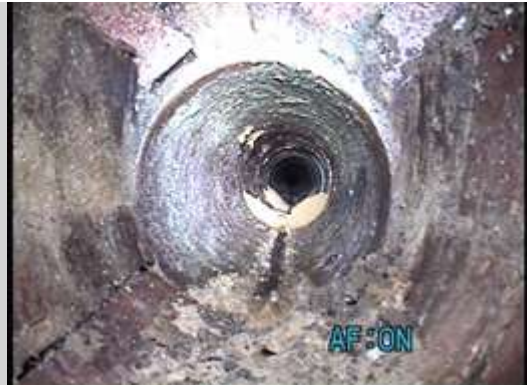
6 O'Clock Inflow

8 in. Circular Gravity Sewer

Pipe In @ 6 O'Clock

Pipe Height: **8.4** (in.) Rod and Bar (Angled)

Infiltration: **None** Pipe Seal Cond: **Sound**
